**ADVANCED COMPOSITE RUDDERS
FOR DC-10 AIRCRAFT — DESIGN, MANUFACTURING,
AND GROUND TESTS**

By George M. Lehman, et al

Prepared Under Contract No. NAS1-12954

McDonnell Douglas Corporation
Douglas Aircraft Company
Long Beach, California 90846

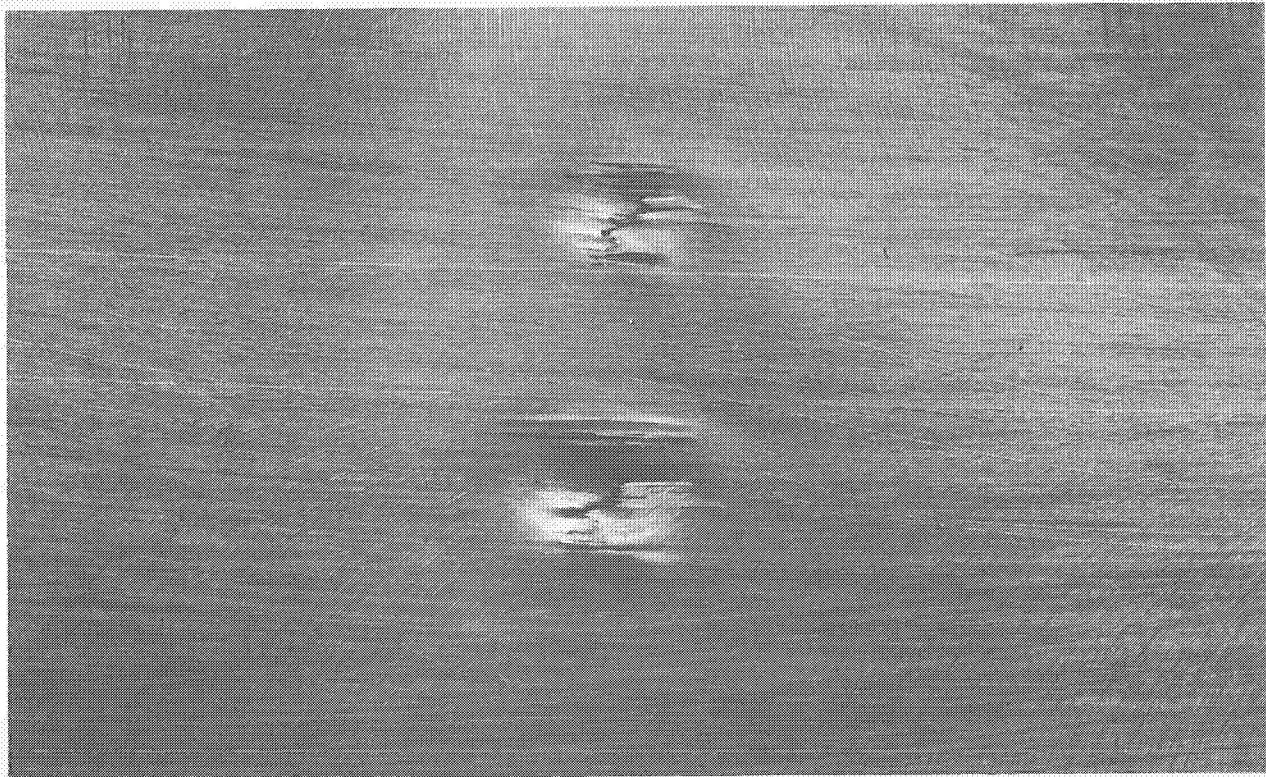
(A) PANEL NO. 3

(B) PANEL NO. 4

FIGURE 23. FRACTURE TOUGHNESS PANEL DAMAGE LEVELS

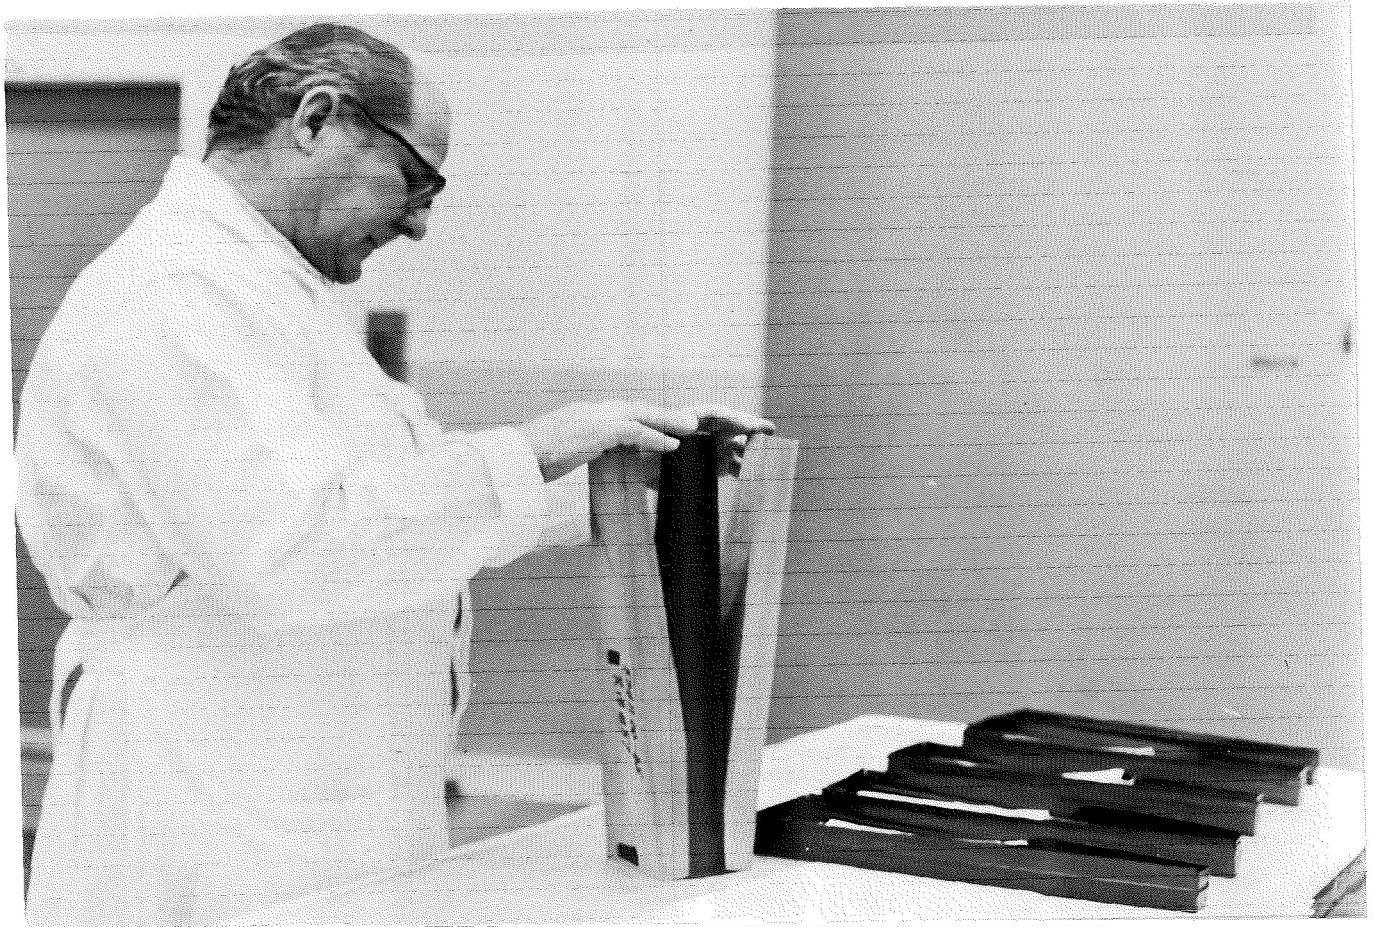
FIGURE 45. PREFORMED GRAPHITE RIBS AND FORM BLOCKS

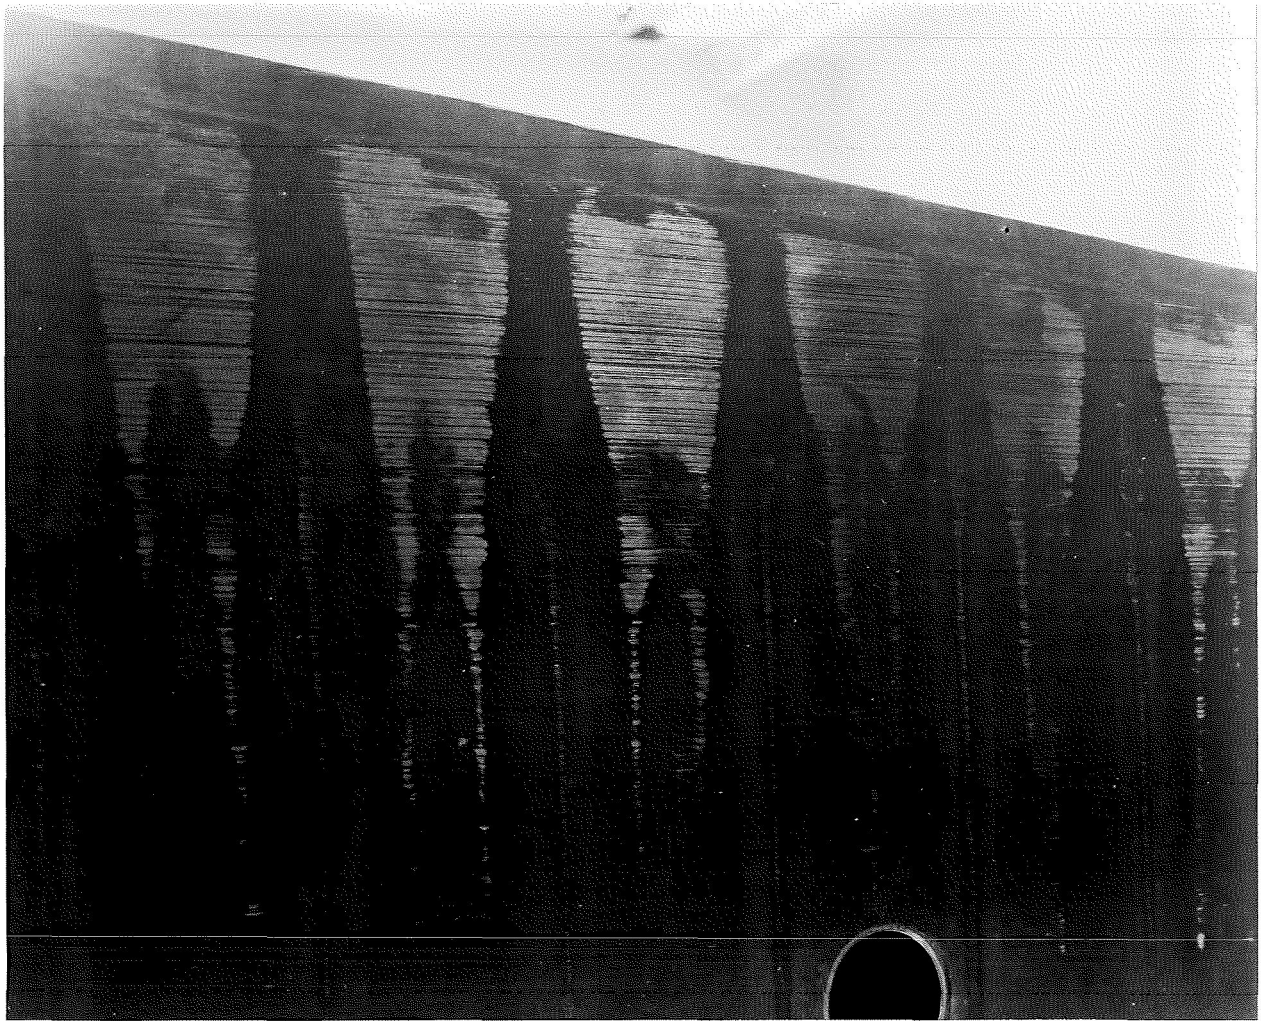
FIGURE 51. SKIN SURFACE POROSITY IN DEVELOPMENT RUDDER UNIT 3

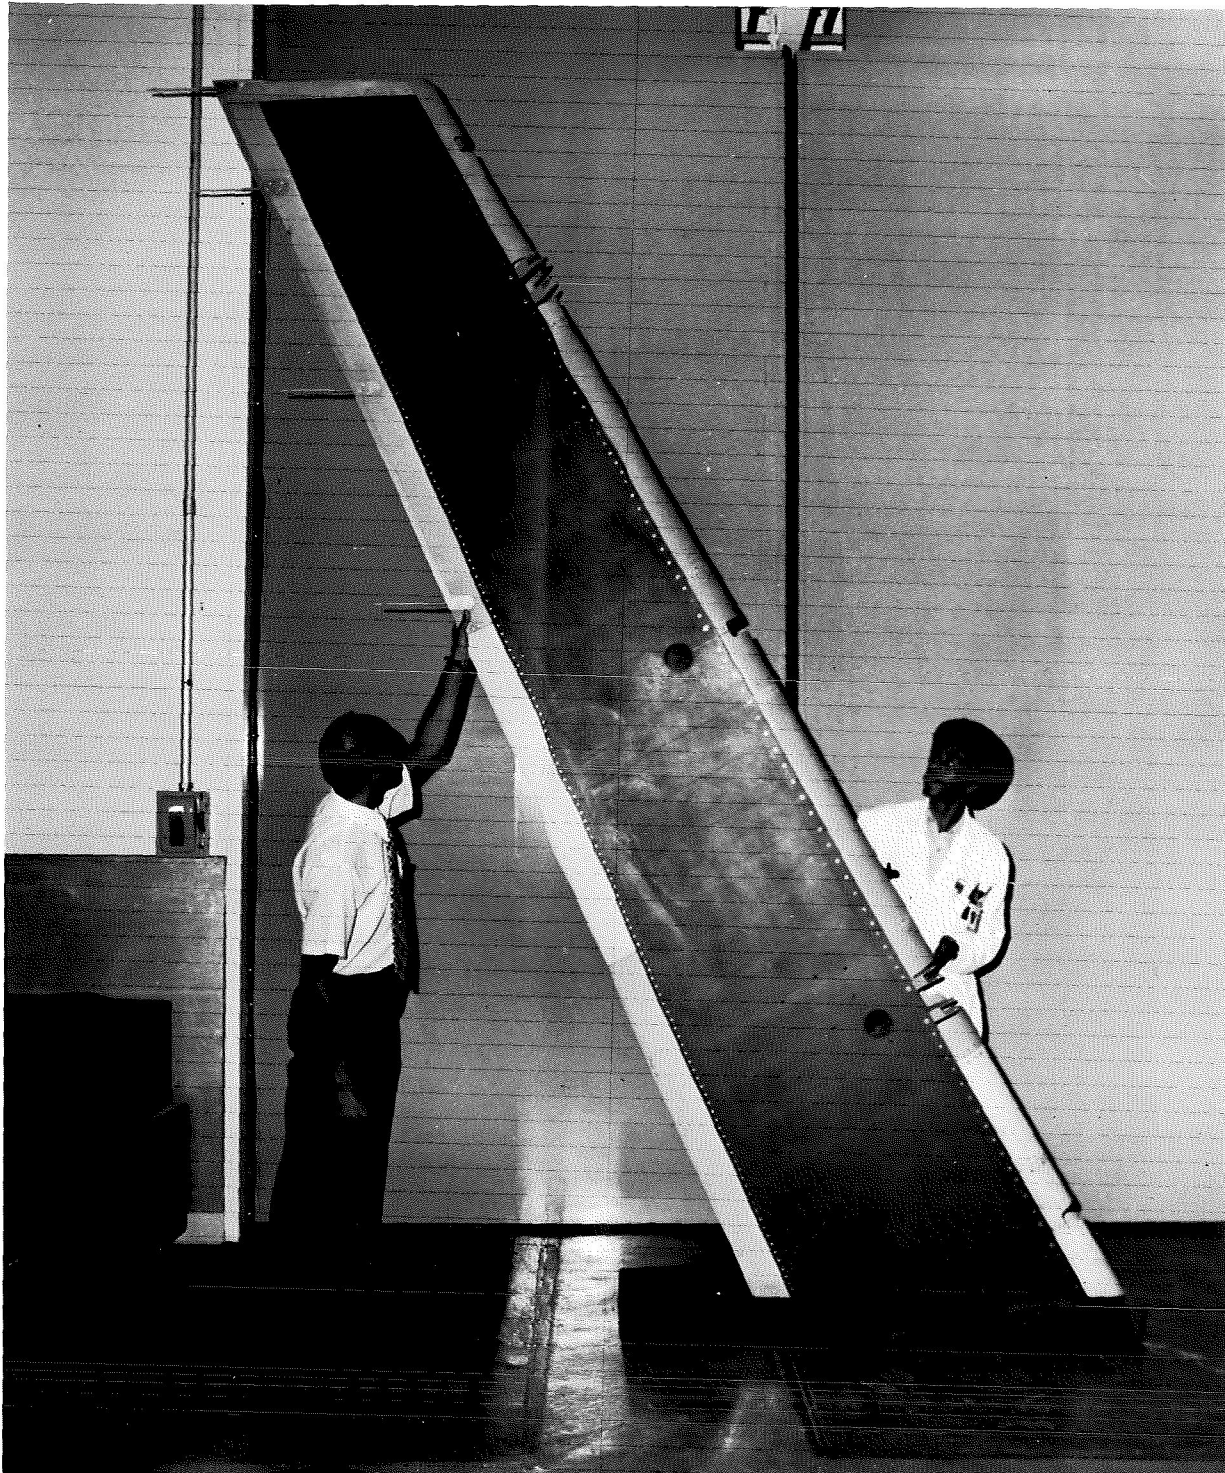
FIGURE 56. RUDDER STATIC TEST COMPONENT

The fourth rudder unit was accepted for static tests after satisfactory completion of the tag-end tests and non-destructive inspection. The graphite molding assembly was trimmed net and installed in the final assembly jig for installation of the hinge fittings, leading and trailing edges, and tip structure. The completed static test rudder is shown in Figure 56.
